BOROUGH OF ZELIENOPLE
Butler County,
Pennsylvania

Stormwater Evaluation Report
(Spring Street & Glade Run Watersheds)

July 2019

Stream Survey

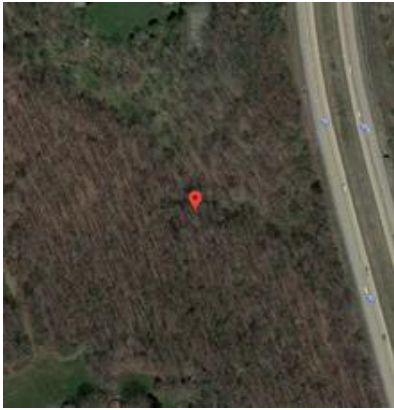
Wooden Object

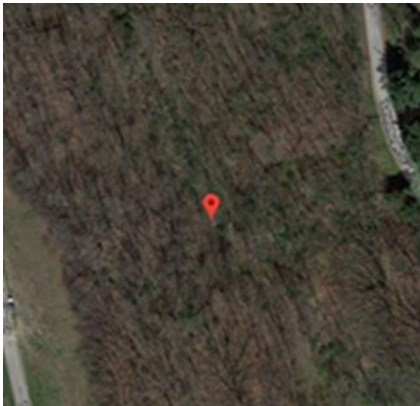
Tire

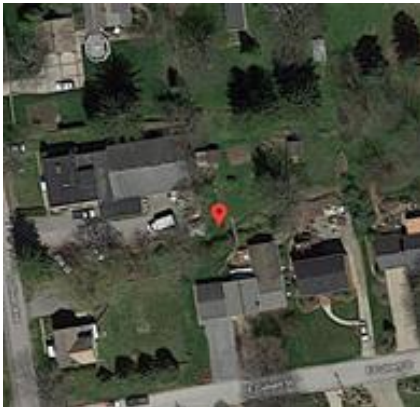
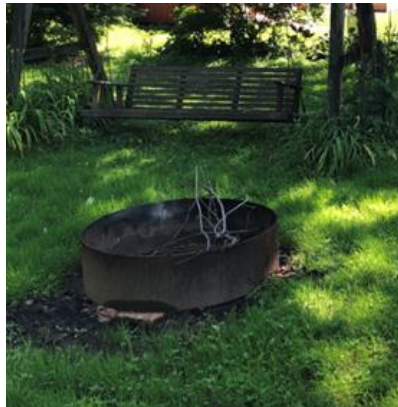
Fire Pit

I don't believe that this was secured

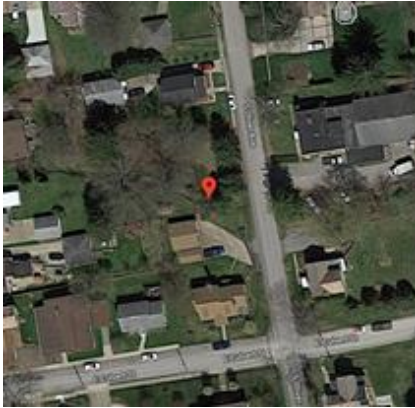
Many

Bricks, brush, wooden supports, rock retaining wall next to pipe opening

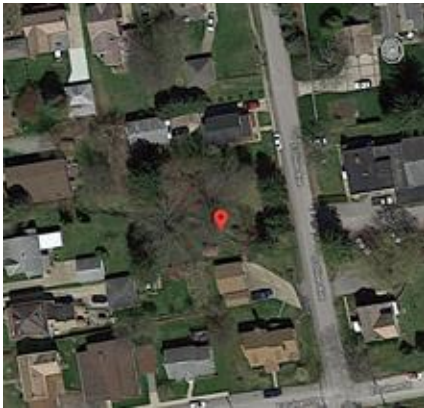
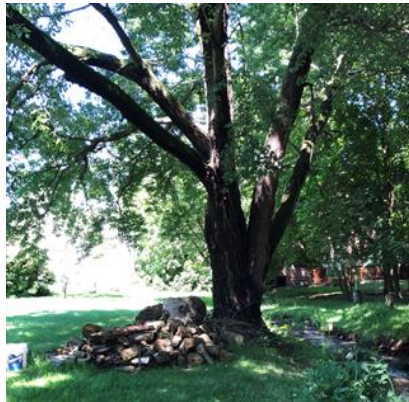
Firewood Pile

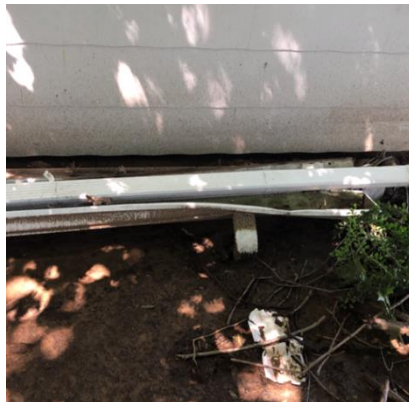
Pipe Supports

Located immediately next to stream

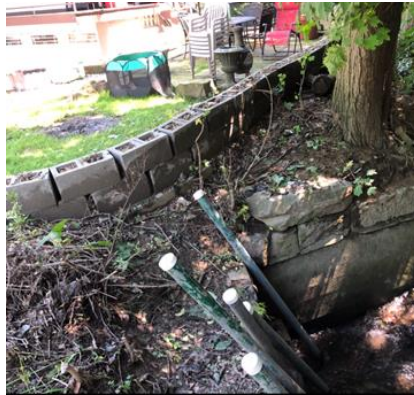
Wooden Brush and Bricks

Bricks appear to be homemade retaining wall.

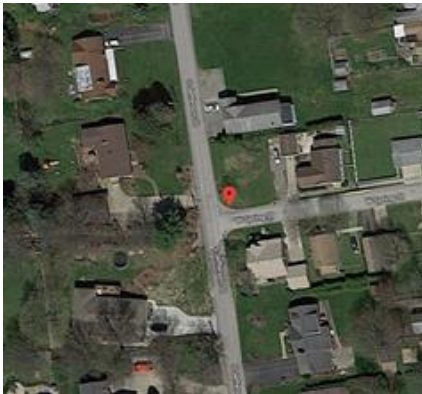
Firewood Pile and Wooden Brush

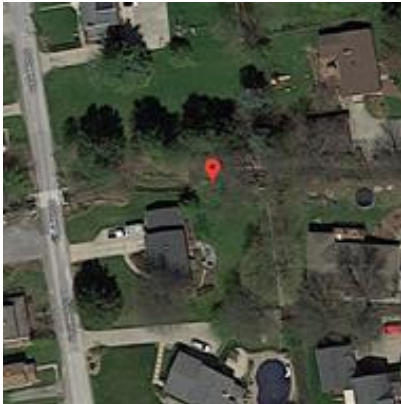
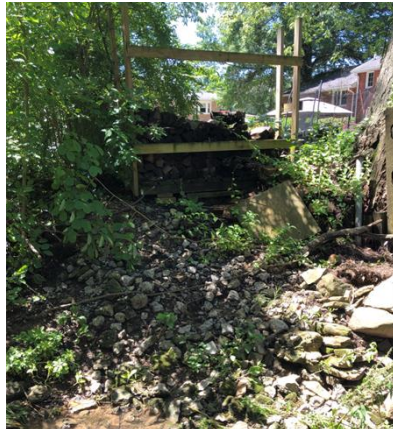
Rock and Firewood

Firewood File Supports appear unstable. Various pieces of rock, brick, and wood next to it.

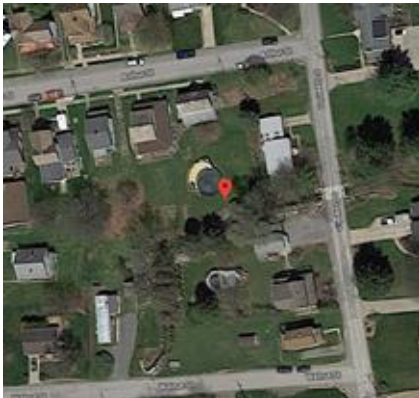
Type of Obstruction: Lawn Clippings and Various Debris

Notes: Brush, loose items, lawn clippings, metal piping, large rocks

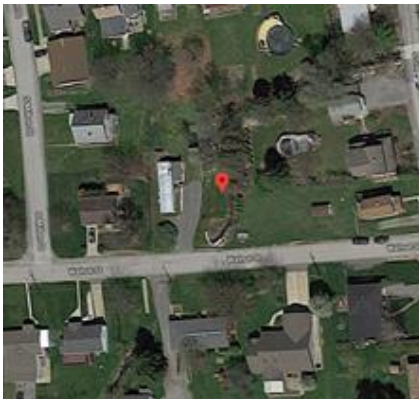
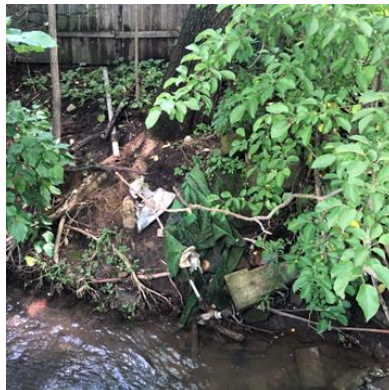
Type of Obstruction: Turf and Various Debris

Notes: Large piece of cloth turf folded on stream bank

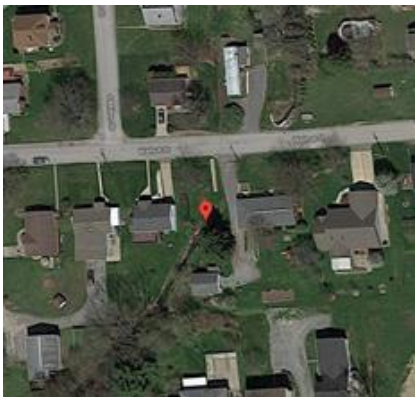
Type of Obstruction: Lawn Clippings

Notes: Large Pile

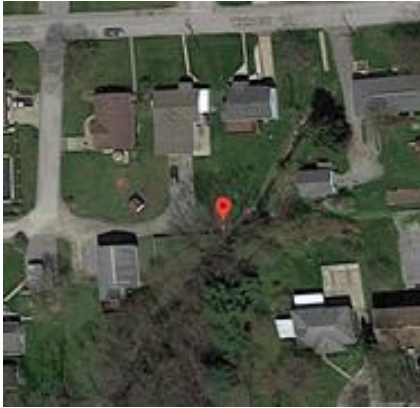
Type of Obstruction: Horizontal Pipe

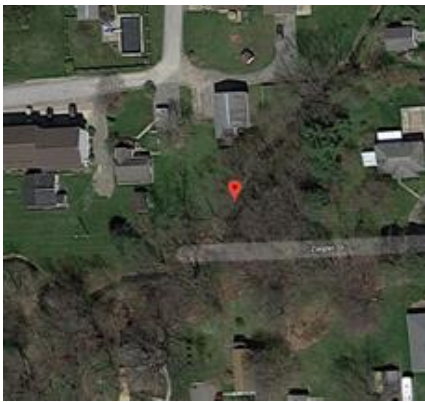
Type of Obstruction: Lawn Clippings

Notes: Large Pile

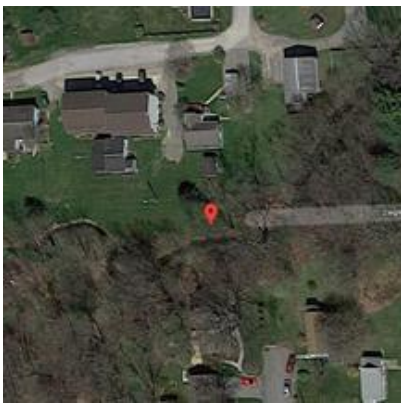
Type of Obstruction: Various Debris

Notes: Bricks, brush, lawn clippings, secured fire pit

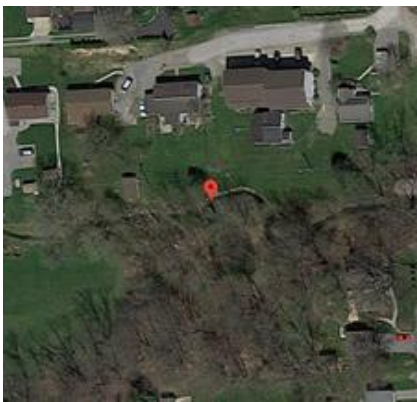
Type of Obstruction: Homemade planting Bed

Notes: Rocks, wooden planks, brush

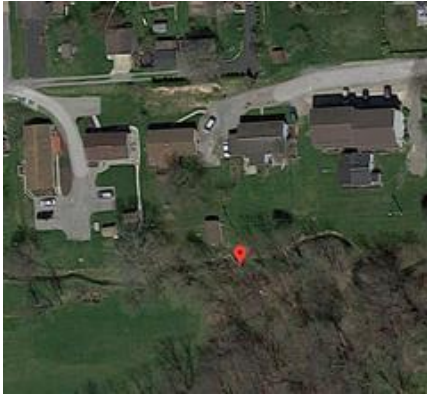
Various Debris

Wooden planks, metal, mesh netting, bricks, wooden brush

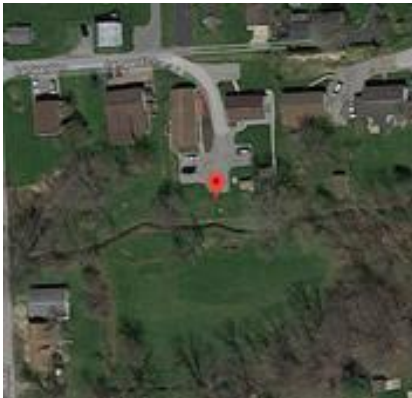
Lawn Clippings

Large Pile

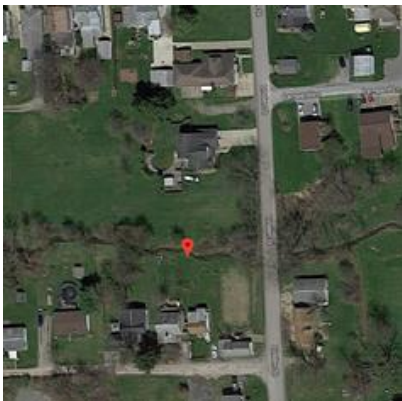
Wood and Blocks

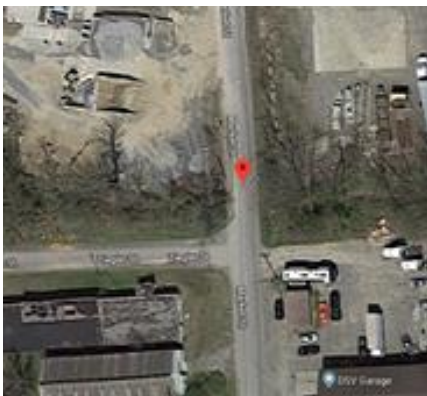
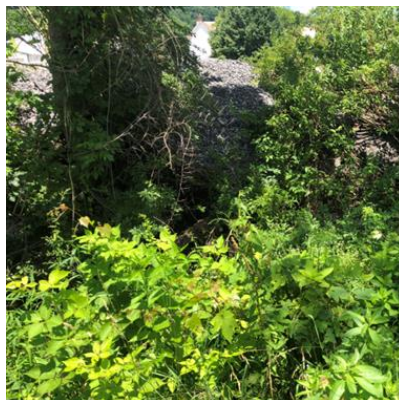
Gravel Pile

Huge Gravel Pile bordering edge of stream from industrial park

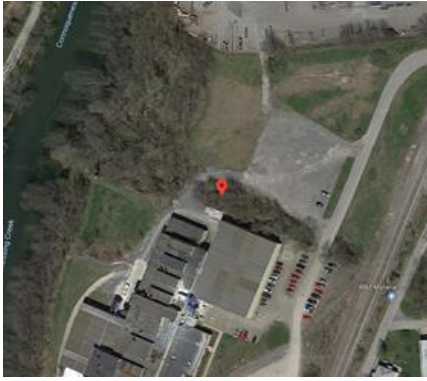
Various Debris

Trash by edge overlooking stream from materials plant.

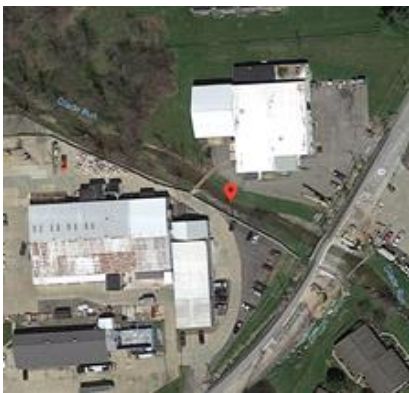
- A number of locations throughout the Spring Street Watershed where debris from human activity is currently impacting streams were identified. Debris included asphalt from an adjacent parking lot falling into stream and wooden debris. Debris identified was located on the banks of the stream. This debris may cause water backups and the potential for more flooding. Refer to Pages 9 and 10 of the Survey Report in Attachment B.,

Parking Lot

Portion of parking lot sliding into stream

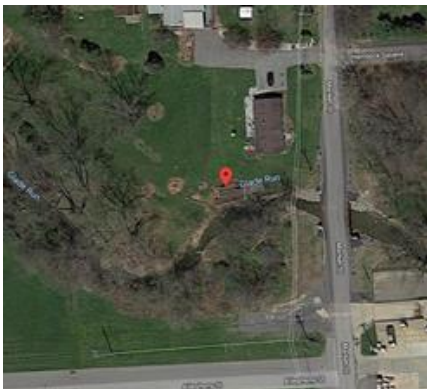
Various wooden Debris

Including Plywood

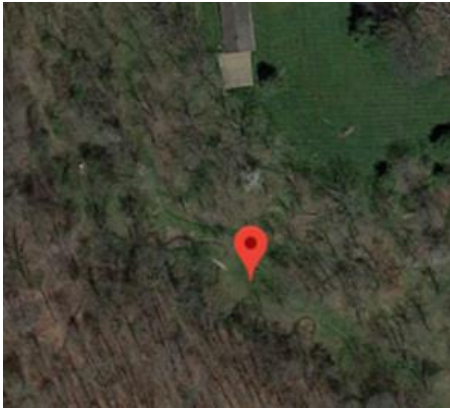
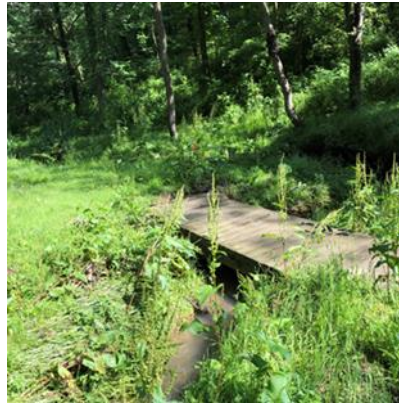
- Footbridge located off of Parkedge Dr. Current clearance above streambed is approximately 12.5". Refer to Page 12 of the Survey Report in Attachment B.

Type of Obstruction: Bridge

Notes: Bridge Clearance is ~12.5 in. from stream bed

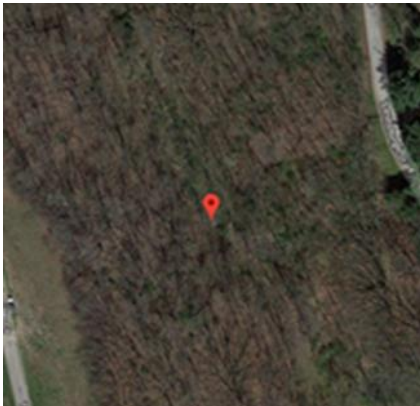
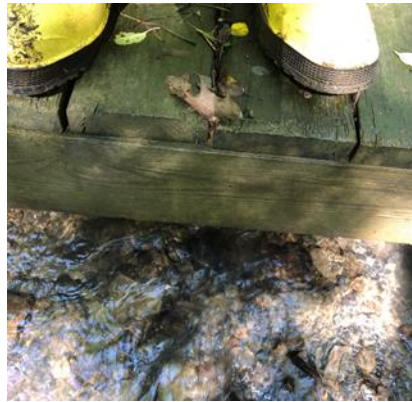
- Footbridge located east of the intersection of S Pittsburgh St. and Terrace Ave Exd. Current clearance above streambed varies from 4" to 19" across the length of the bridge. Refer to Page 12 of the Survey Report in Attachment B.

Type of Obstruction: Bridge

Notes: Bridge Clearance is max ~19 in, min ~4 in. from stream bed

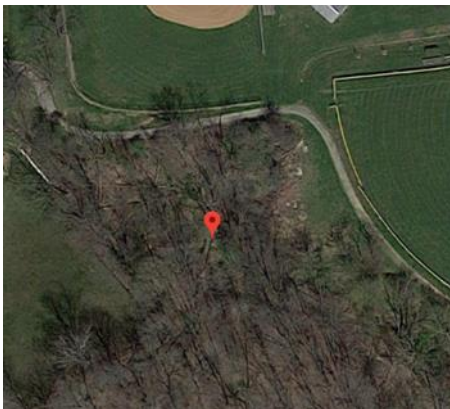
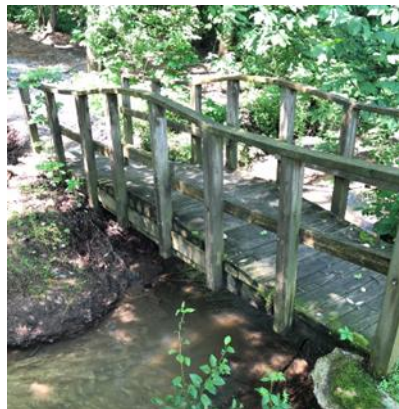
- Footbridge located off Tom Schneider Circle east of the Zelenople Pool. Current clearance above streambed is approximately 36". Refer to Page 12 of the Survey Report in Attachment B.

Type of Obstruction: Bridge

Notes: Bridge Clearance is ~36 in. from stream bed

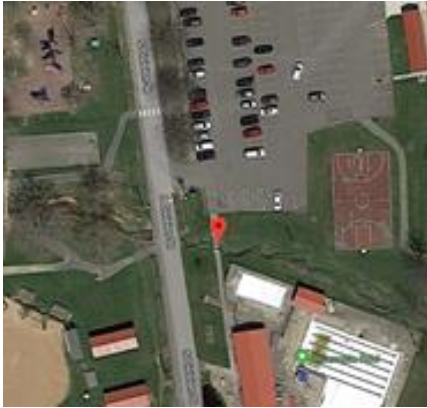
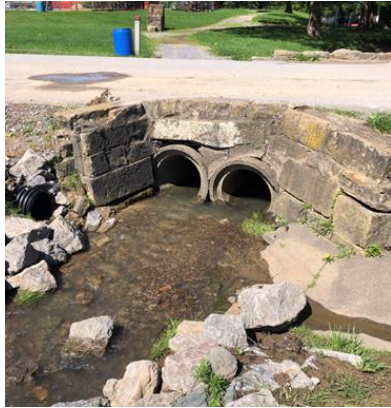
- Culvert located off S Division St. near Zelenople Pool. The culvert consists of two 24" diameter concrete pipes. Refer to Page 13 of the Survey Report in Attachment B.

Bridge & Pipe

Notes: Two pipe bridge.
Both diameters
~23.5 in.

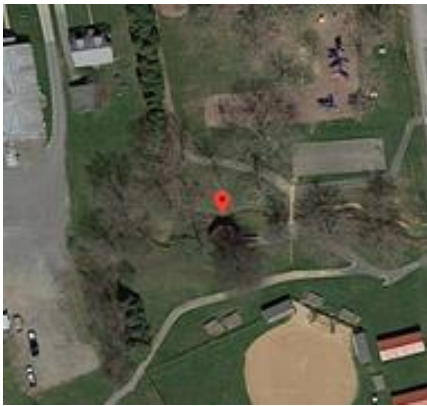
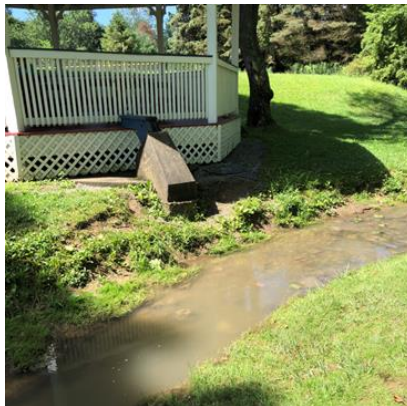
Gazebo

Notes: Gazebo support
and gazebo on
direct edge of
stream bed

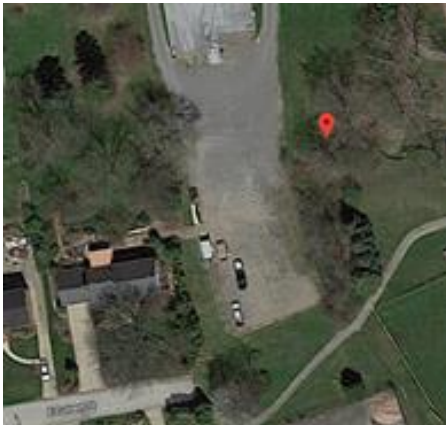
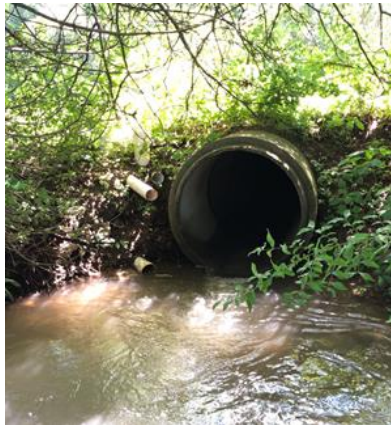
Pipe

Notes: Brush covering
pipe.
Estimated
between 36-39
in. diameter.

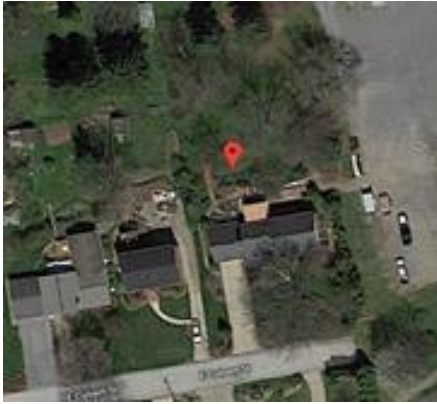
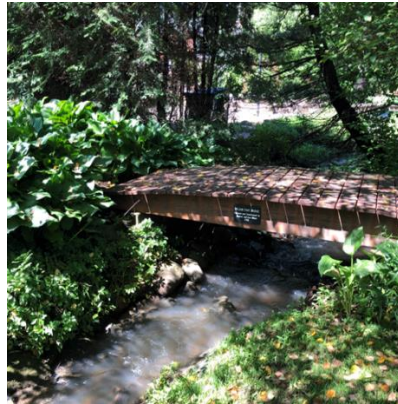
- Footbridge located north 309 E Culvert St. near the community baseball field. Current clearance above streambed is approximately 34.5". Homeowner confirmed water level reaches 6" below bridges during rain events. Refer to Page 14 of the Survey Report in Attachment B.

Type of Obstruction: Bridge
GPS Coordinates: [40°47'32.1"N](#)
[80°07'57.2"W](#)
Notes: Clearance: 34.5 in. Homeowner said water level reached about 6 inches below bridge .

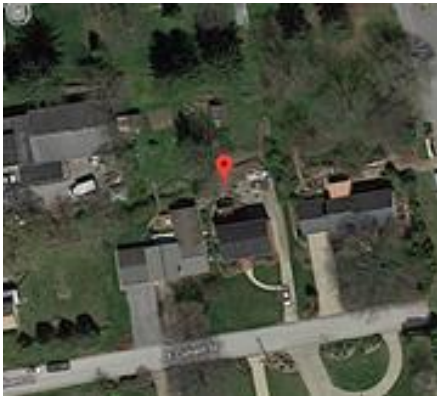
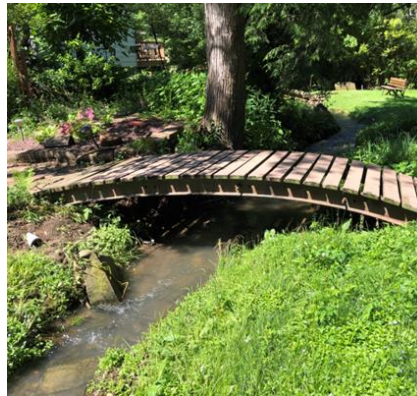
- Footbridge located north 307 E Culvert St. near the community baseball field. Current clearance above streambed is approximately 37". Refer to Page 14 of the Survey Report in Attachment B.

Type of Obstruction: Bridge
GPS Coordinates: [40°47'31.9"N](#)
[80°07'58.2"W](#)
Notes: Bridge clearance ~37 in.

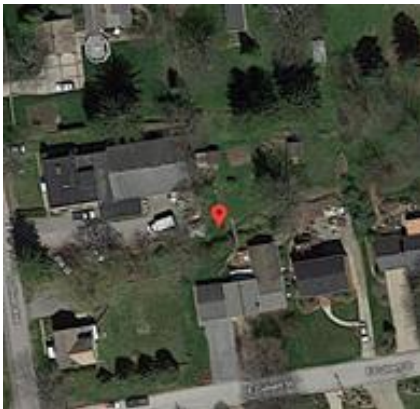
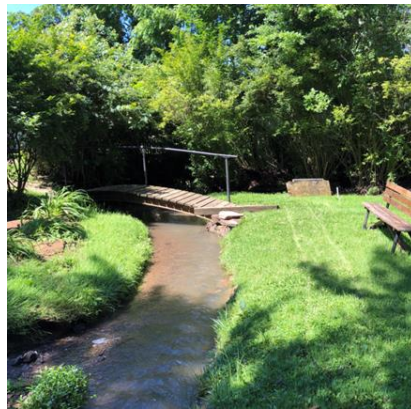
Type of Obstruction: Bridge
GPS Coordinates: [40°47'31.8"N](#)
[80°07'59.1"W](#)
Notes: Bridge clearance ~25 in.

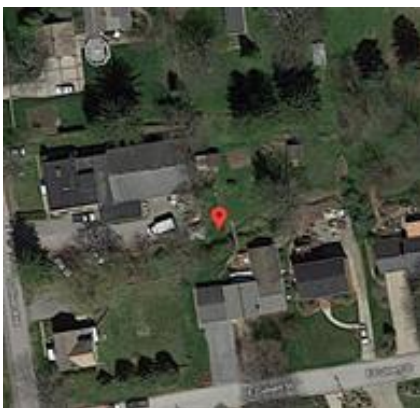
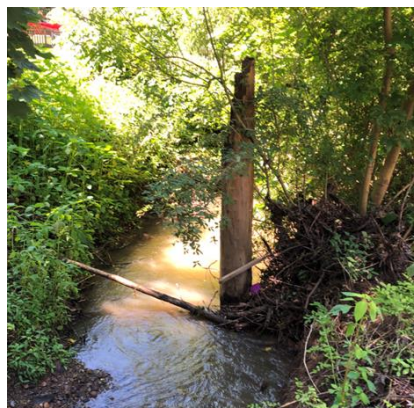
Type of Obstruction: Snapped Post
GPS Coordinates: [40°47'31.8"N](#)
[80°07'59.1"W](#)
Notes:

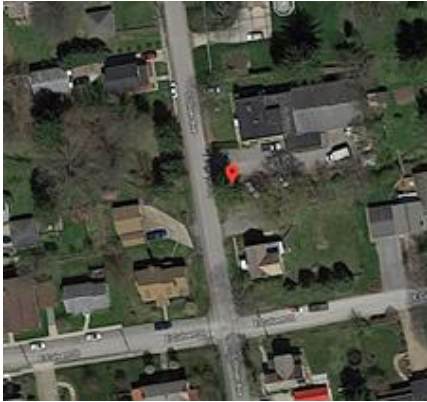
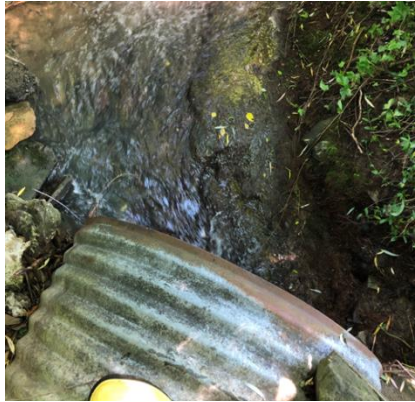
- Culvert located on the eastside of S Oliver St. between E Beaver St. and E Culvert St. The culvert consists of one 40" diameter Corrugated Metal Pipe. Refer to Page 15 of the Survey Report in Attachment B.

Type of Obstruction: Pipe

Notes: Pipe diameter ~40 in, driveway immediately next to screen

After extensive review of the information gathered from the June 21, 2019 field visit, GF recommends stormwater rehabilitation be focused towards the Spring Street Watershed mainly at the seven culvert locations identified in the Survey Report. These seven locations are potential bottlenecks in the storm system making them high priority rehabilitation sites. Additional analysis should be performed for these seven sites to confirm they all have the capacity to convey the peak design flow and size them appropriately if they cannot. GF also recommends the Borough monitor all the footbridges and aerial crossing locations to ensure debris is not getting caught creating blockage in the stream at these locations.

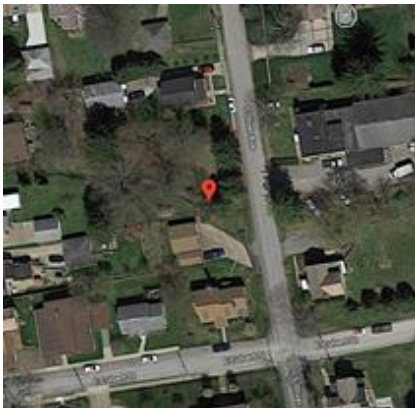
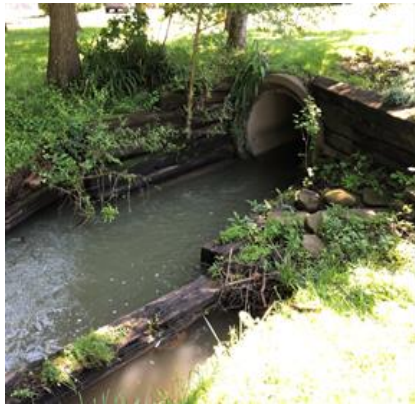
- Culvert located near the intersection of S Oliver Ave. and E Culvert St. The culvert consists of one 45" diameter concrete pipe. Refer to Page 15 of the Survey Report in Attachment B.

Type of Obstruction: Pipe & Wood Supports

Notes: Pipe diameter ~45 in. Wood supports in stream, rock pile to stream side.

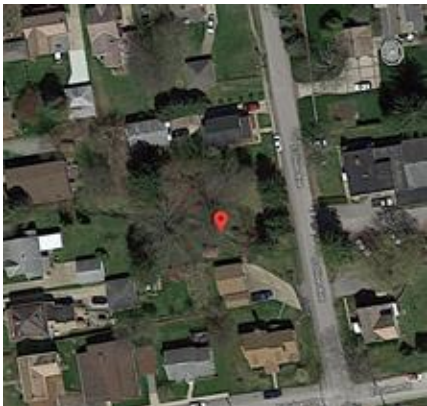
- Culvert/Walking Bridge located on the westside S Oliver St. between E Beaver St. and E Culvert St. The culvert consists of one 41" diameter Corrugated Metal Pipe. Refer to Page 15 of the Survey Report in Attachment B. As can be seen from the pictures in attachment B, significant debris is currently coking the flow through this culvert.

Type of Obstruction: Bridge & Pipe

Notes: Pipe diameter ~41 in. Large debris in front of pipe.

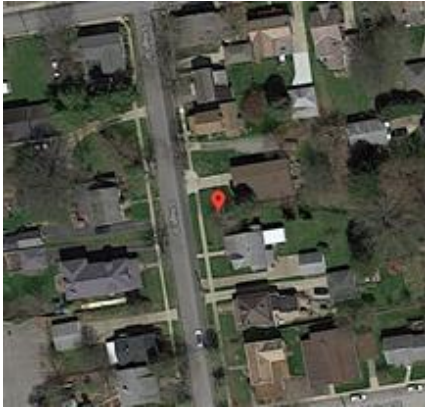
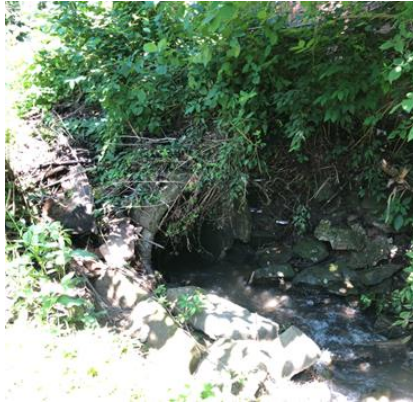
- Culvert located off S High St in between E Beaver St. and E Culvert St. The culvert consists of one 50" diameter concrete pipe. Refer to Page 16 of the Survey Report in Attachment B.

Type of Obstruction: Pipe

Notes: Pipe diameter ~49-51 in.

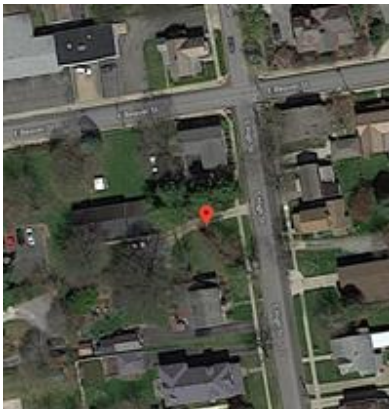
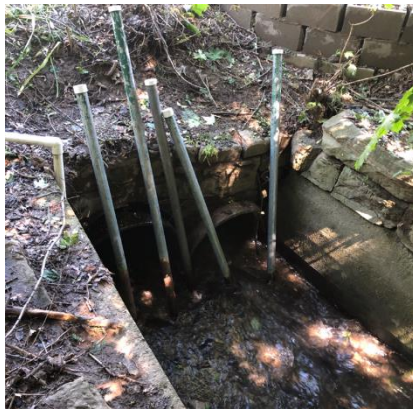
- Culvert located near the intersection of S High St and E Beaver St. The culvert consists of two 20" diameter concrete pipes. Refer to Page 16 of the Survey Report in Attachment B.

Type of Obstruction: Pipe

Notes: Both pipe diameters ~19-21 in.

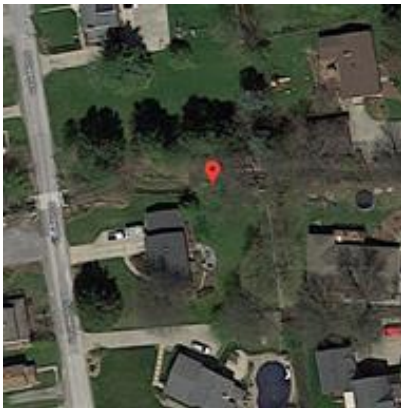
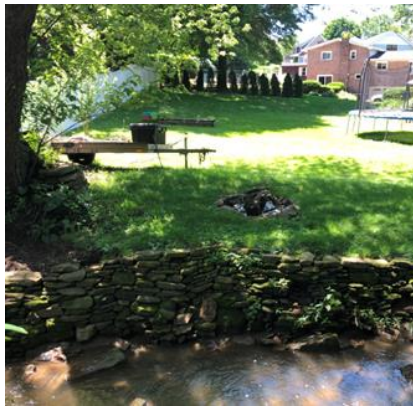
Type of Obstruction: Retaining Wall

Notes: Retaining Wall possibly made by homeowner

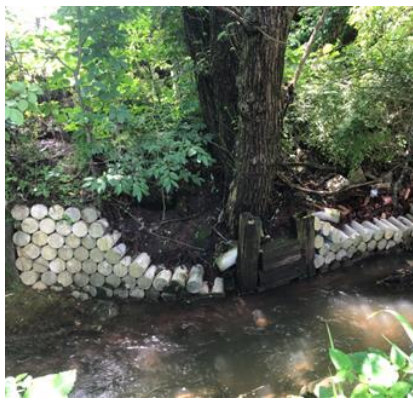
Type of Obstruction: Retaining Wall

Notes: Retaining Wall possibly made by homeowner

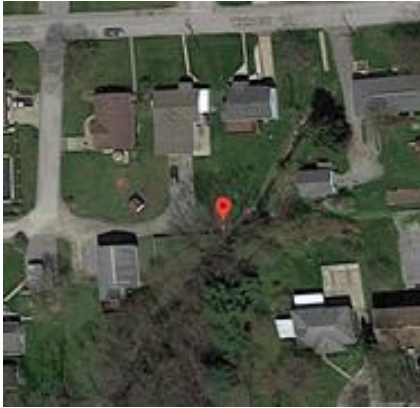
Type of Obstruction: Horizontal Pipe

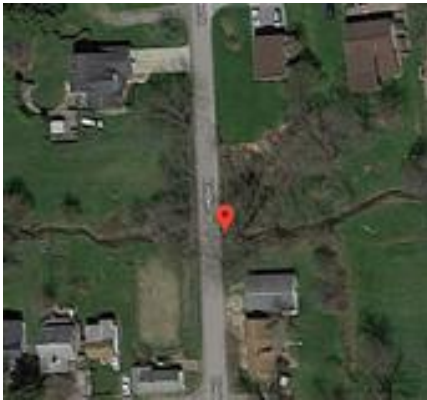
- Culvert located off Linden St. Due to the location of the culvert, the diameter was unable to be recorded. Refer to Page 17 of the Survey Report in Attachment B.

Type of Obstruction: Pipe

Notes: Unable to get pipe diameter due to location

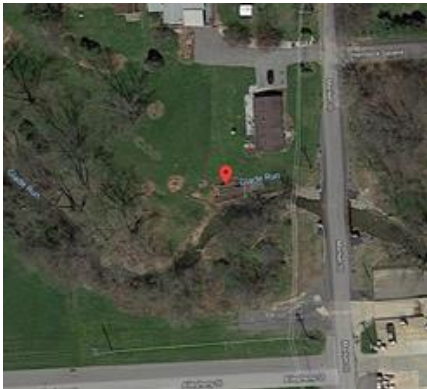
- Shed of homeowner at 701 Market St. is currently fallen into Glade Run Stream. As the bank continues to erode, the entire shed will eventually block all or most of the existing stream channel. Refer to Page 17 of the Survey Report in Attachment B.

Type of Obstruction: Shed

Notes: Shed beginning to fall into stream

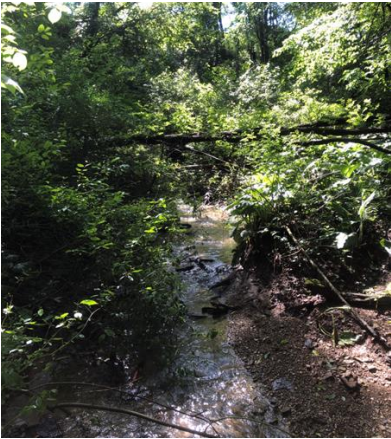
Fallen Tree

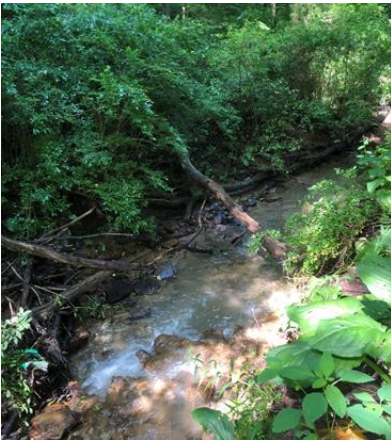
Fallen Tree

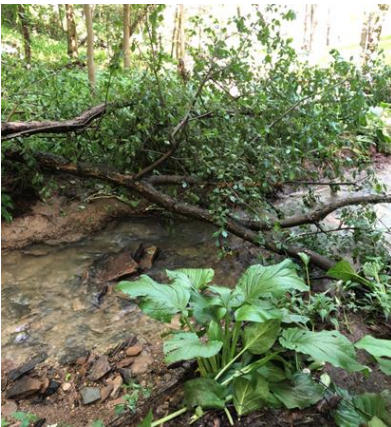
Fallen Tree

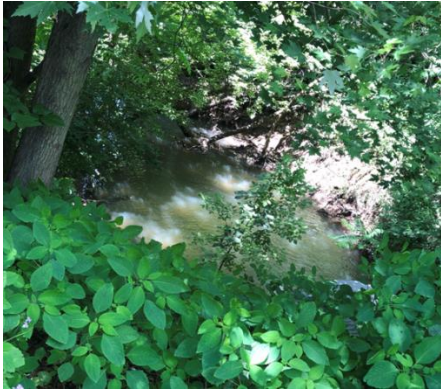
Type of Obstruction: Fallen Tree
Wooden Brush

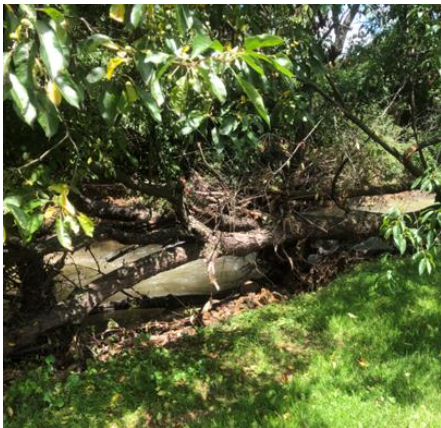
Type of Obstruction: Fallen Tree
Wooden Brush

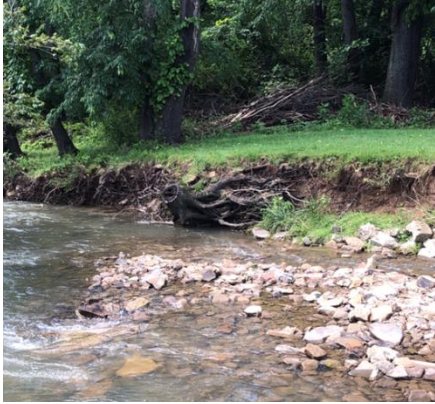
Type of Obstruction: Fallen Tree
Wooden Brush
