BOROUGH OF ZELIENOPLE
Butler County,
Pennsylvania

Stormwater Evaluation Report
(Spring Street & Glade Run Watersheds)

July 2019

Stream Survey

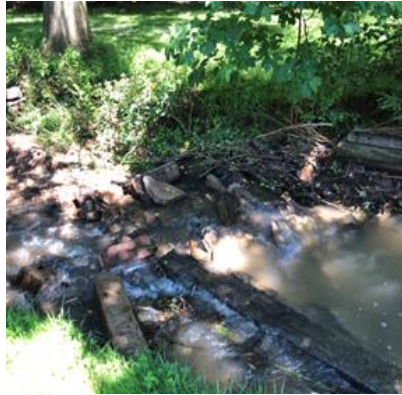
Many

Bricks, brush, wooden supports, rock retaining wall next to pipe opening

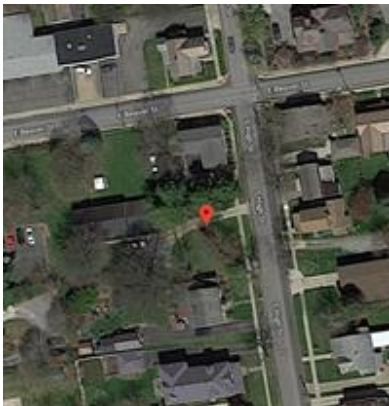
Pipe Supports

Located immediately next to stream

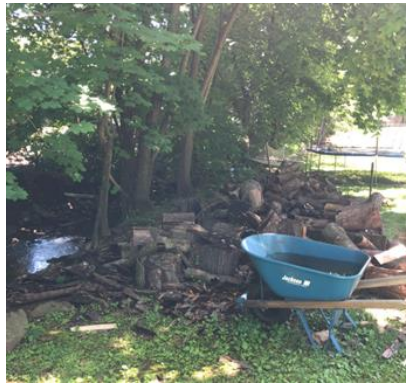
Firewood Pile and Wooden Brush

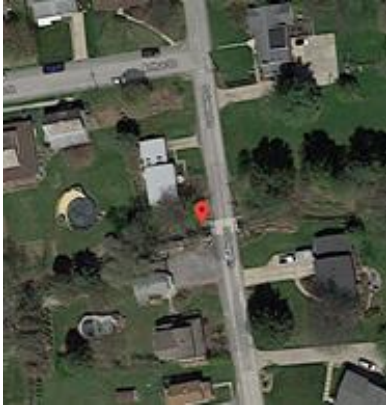
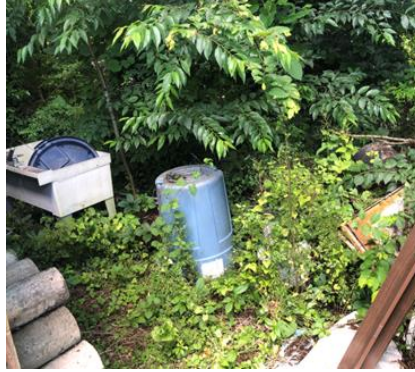
Type of Obstruction: Misc. Homeowner Debris

Notes: Other various items to the right of this image

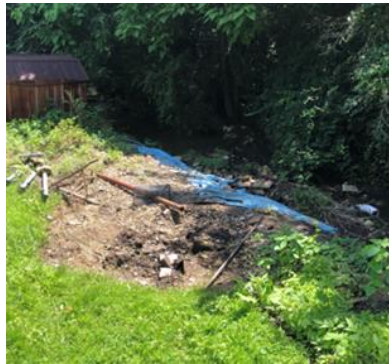
Type of Obstruction: Lawn Clippings and Various Debris

Notes: Brush, loose items, lawn clippings, metal piping, large rocks

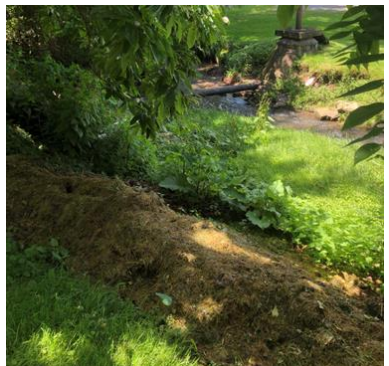
Type of Obstruction: Lawn Clippings

Notes: Large Pile

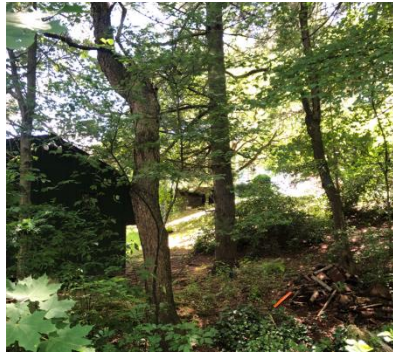
Type of Obstruction: Horizontal Pipe

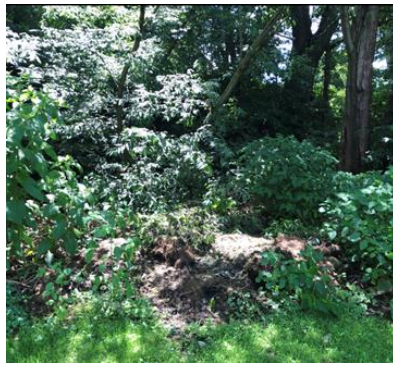
Type of Obstruction: Lawn Clippings

Notes: Large Pile

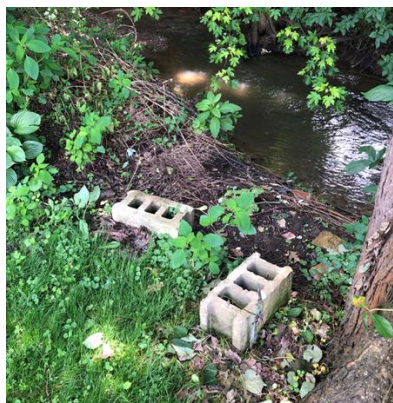
Type of Obstruction: Various Debris

Notes: Bricks, brush, lawn clippings, secured fire pit

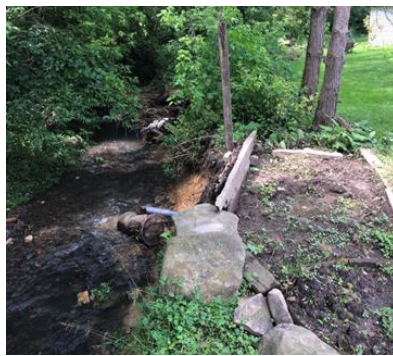
Type of Obstruction: Homemade planting Bed

Notes: Rocks, wooden planks, brush

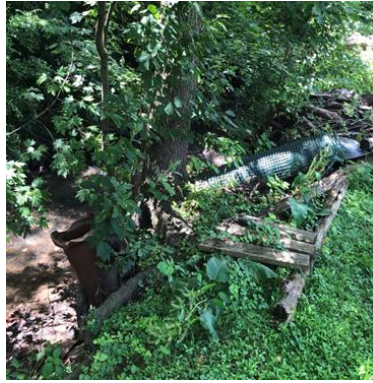
Various Debris

Wooden planks, metal, mesh netting, bricks, wooden brush

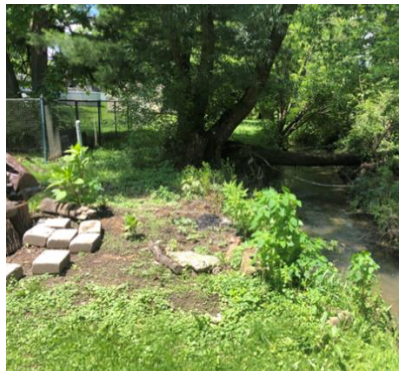
Wood and Blocks

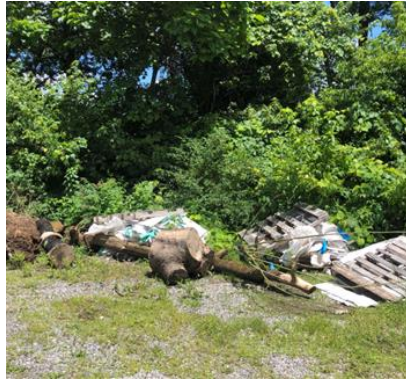
Various Debris

Trash by edge overlooking stream from materials plant.

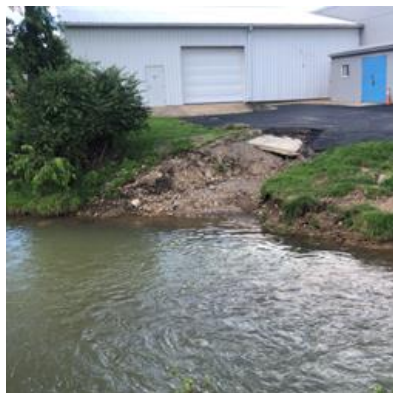
Parking Lot

Portion of parking lot sliding into stream

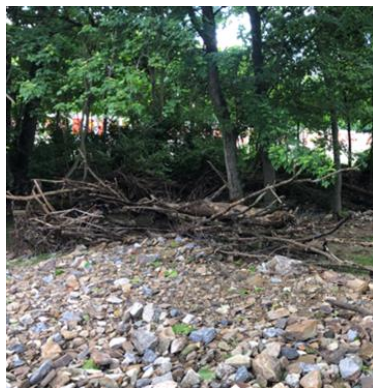
Various wooden Debris

Including Plywood

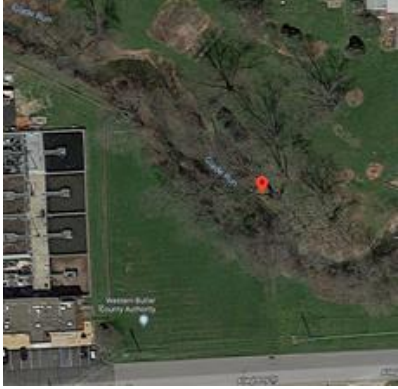
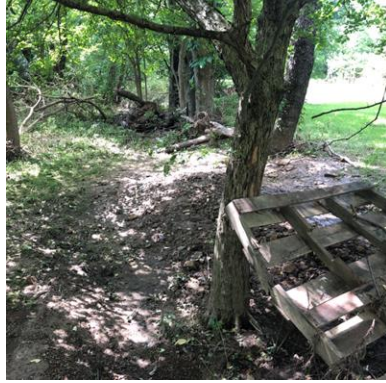
Wooden Pallet

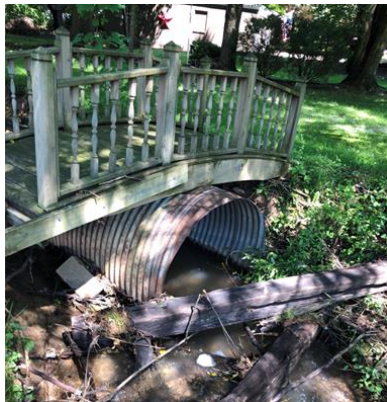
Type of Obstruction: Bridge & Pipe

Notes: Pipe diameter ~41 in. Large debris in front of pipe.

After extensive review of the information gathered from the June 21, 2019 field visit, GF recommends stormwater rehabilitation be focused towards the Spring Street Watershed mainly at the seven culvert locations identified in the Survey Report. These seven locations are potential bottlenecks in the storm system making them high priority rehabilitation sites. Additional analysis should be performed for these seven sites to confirm they all have the capacity to convey the peak design flow and size them appropriately if they cannot. GF also recommends the Borough monitor all the footbridges and aerial crossing locations to ensure debris is not getting caught creating blockage in the stream at these locations.

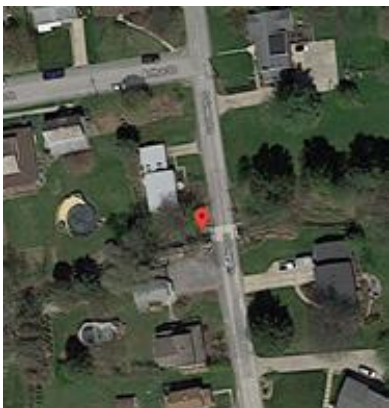
Type of Obstruction: Retaining Wall

Notes: Retaining Wall possibly made by homeowner

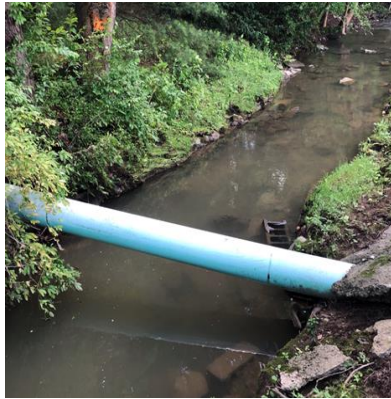
Type of Obstruction: Horizontal Pipe

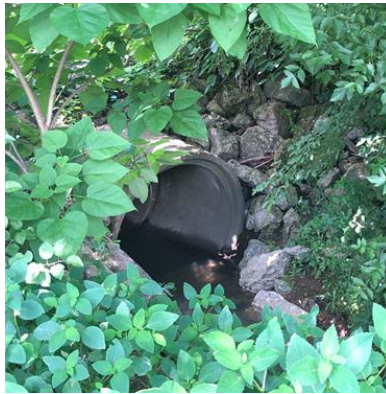
Type of Obstruction: Pipe

Notes: Unable to get pipe diameter due to location

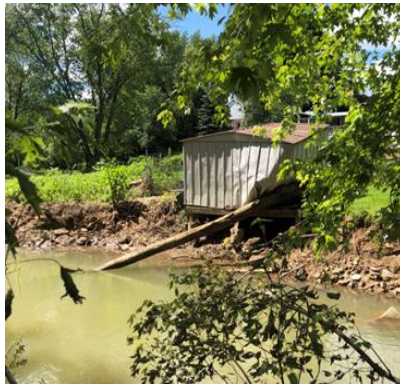
Type of Obstruction: Shed

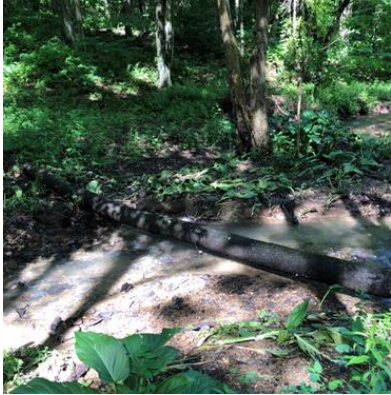
Type of Obstruction: Fallen Tree
Wooden Brush

Lastly, creating a cleanup plan for both the Spring Street and Glade Run Watersheds is recommended. The Borough should first look to remove all fallen trees and debris (tires, wooden object, etc.) that are directly impacting stream channels throughout the two watersheds. The Borough should then contact Borough residences that have or could potential impact stream flow as a result of activity outlined in the Survey Report in Attachment B.

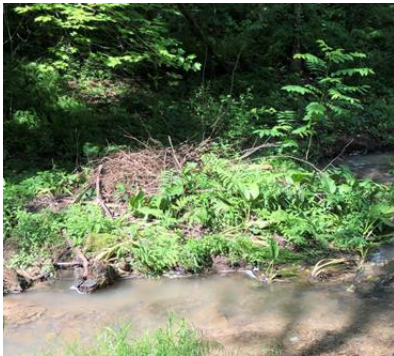
Type of Obstruction: Wooden Brush

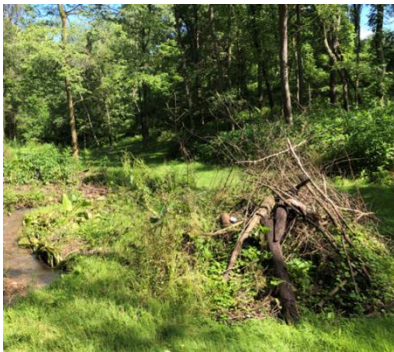
Type of Obstruction: Wooden Brush

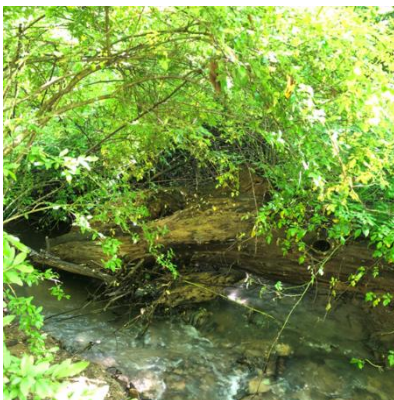
- Through the Spring Street Watershed, 17 location were identified where trees had fallen directly into the stream channel. It was observed during GF's field visit that at each of the 17 location, the natural stream flow had been coked as a result of these impacts. Refer to Pages 19 – 23 of the Survey Report in Attachment B.

Type of Obstruction: Fallen Tree

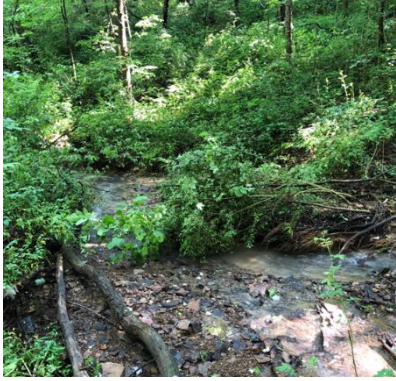
Fallen Tree

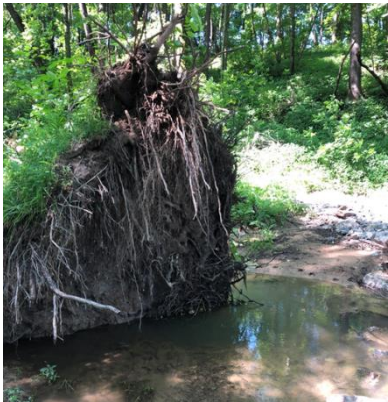
Fallen Tree

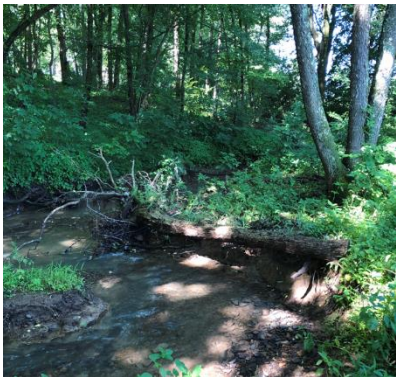
Fallen Tree
Wooden Brush

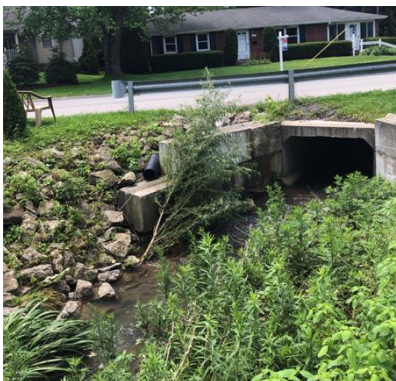
Fallen Tree

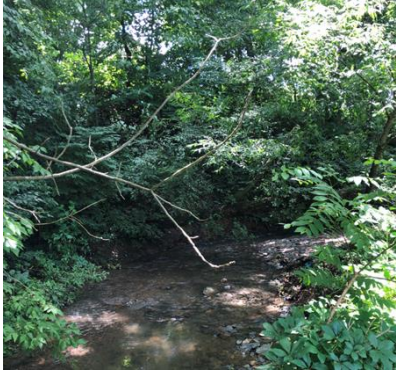
Fallen Tree

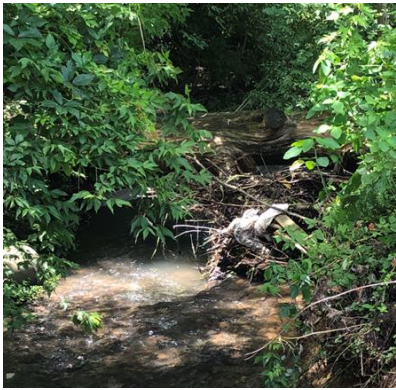
Fallen Tree

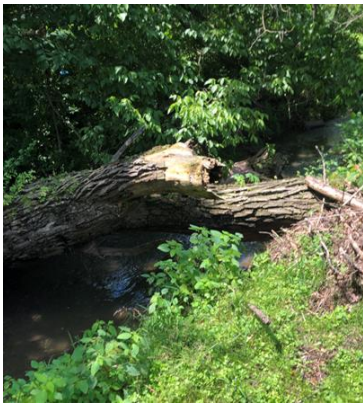
Fallen Tree
Wooden Brush

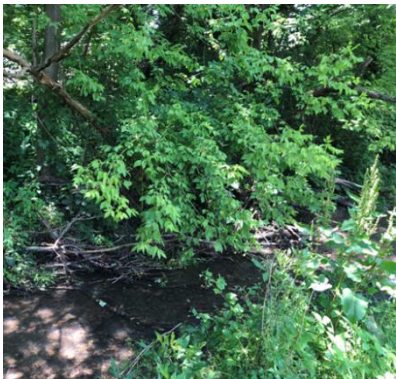
Wooden Brush

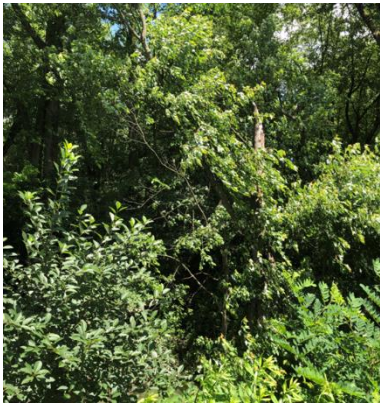
GPS Coordinates: [40°47'34.5"N](#)
[80°08'59.5"W](#)

Type of Obstruction: Fallen Tree
Wooden Brush

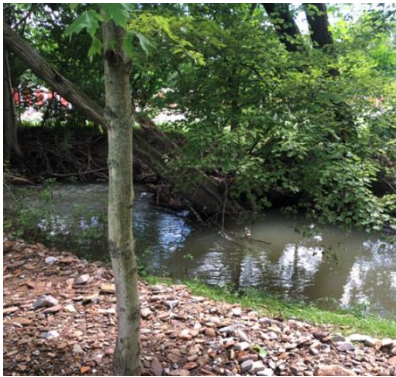
GPS Coordinates: [40°47'13.4"N](#)
[80°08'44.5"W](#)

Type of Obstruction: Fallen Tree
Wooden Brush

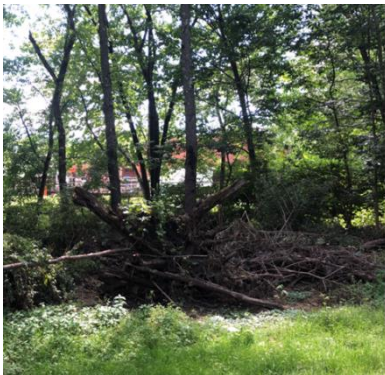
GPS Coordinates: [40°47'14.6"N](#)
[80°08'51.6"W](#)

Type of Obstruction: Fallen Tree

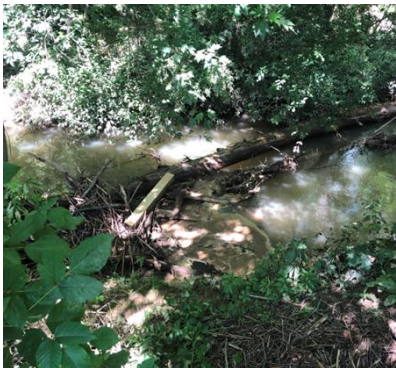
GPS Coordinates: [40°47'15.6"N](#)
[80°08'53.7"W](#)

Type of Obstruction: Wooden Brush
